Kerosene spill at a residential property impacting local watercourse - Aberdeenshire

The Client: Loss Adjuster

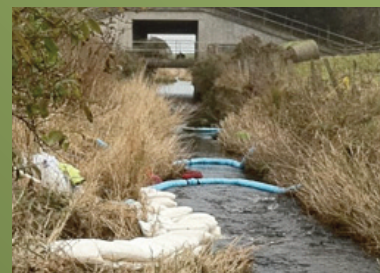
EMERGENCY WORKS

The Solution: Emergency mitigation measures were deployed to prevent migration of kerosene further off-site using absorbent booms deployed in strategic locations. A sandbag barrier wall was constructed along the banking to divert the water flow away from the impacted bank, absorbents were then placed behind the barrier to intercept kerosene before it reached the watercourse.

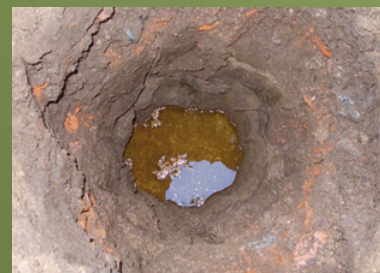
BOREHOLE SHOWING KERSENE IN THE GROUNDWATER

Following an initial site assessment, a drilling rig was rapidly mobilised to site to facilitate assessment of the groundwater conditions. Groundwater extraction boreholes were installed at the same time as the assessment works; one borehole was positioned to extract kerosene from near the spill source, and 3 further boreholes positioned to intercept contamination before it reached the water course.

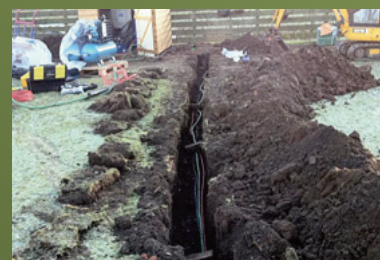
INSTALLATION OF WATER TREATMENT EQUIPMENT

Due to restricted site access a bespoke water treatment system was designed and installed on site. Borehole pumps were installed to extract both free and dissolved phase kerosene from the ground water. The pumps were run on a programmed schedule to enable the system to run 24/7. A self-regulating treatment system was installed to reduce supervision requirements and therefore create cost savings. The system comprised an oil-water separator followed by a carbon filters, all installed within a garden shed with pipes and cables buried to enable full use of the garden by the homeowner.

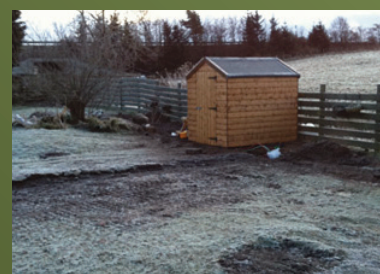
EQUIPMENT CONCEALED IN A GARDEN SHED
