Kerosene spill at a residential property impacting local watercourse - Aberdeenshire

The Client: Loss Adjuster

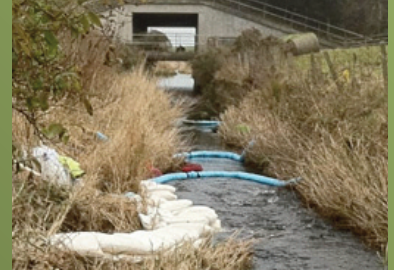
EMERGENCY WORKS

The Solution: Emergency mitigation measures were deployed to prevent migration of kerosene further off-site using absorbent booms deployed in strategic locations. A sandbag barrier wall was constructed along the banking to divert the water flow away from the impacted bank, absorbents were then placed behind the barrier to intercept kerosene before it reached the watercourse.

Emergency Works

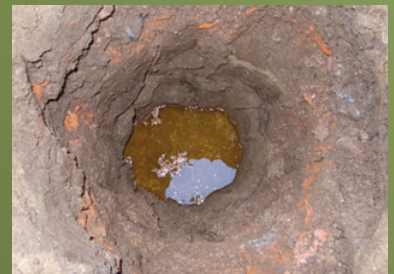
BOREHOLE SHOWING KEROSENE IN THE GROUNDWATER

Following an initial site assessment, a drilling rig was rapidly mobilised to site to facilitate assessment of the groundwater conditions. Groundwater extraction boreholes were installed at the same time as the assessment works; one borehole was positioned to extract kerosene from near the spill source, and 3 further boreholes positioned to intercept contamination before it reached the water course.

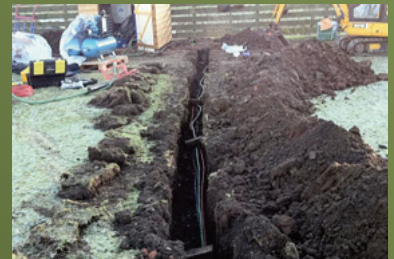
INSTALLATION OF WATER TREATMENT EQUIPMENT

Due to restricted site access a bespoke water treatment system was designed and installed on site. Borehole pumps were installed to extract both free and dissolved phase kerosene from the ground water. The pumps were run on a programmed schedule to enable the system to run 24/7. A self-regulating treatment system was installed to reduce supervision requirements and therefore create cost savings. The system comprised an oil-water separator followed by a carbon filters, all installed within a garden shed with pipes and cables buried to enable full use of the garden by the homeowner.

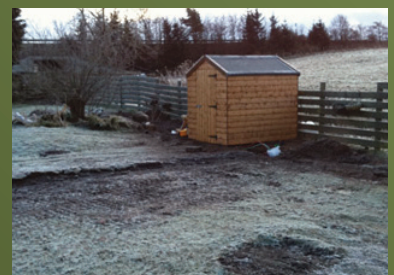
EQUIPMENT CONCEALED IN A GARDEN SHED
