Japanese Knotweed Treatment, Fordell

The Challenge: Soilutions were contracted with the treatment of a stand of Japanese Knotweed (JK) which had resulted from fly tipping in the car park of an activity centre. The JK stand was growing at one end of a busy car park and had spread close to the site boundary.

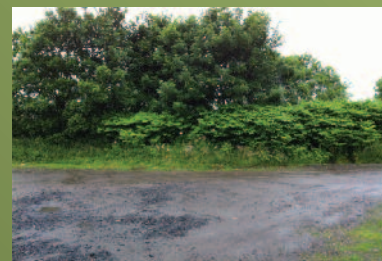
MAIN STAND OF JK TAKEN JUNE 2013

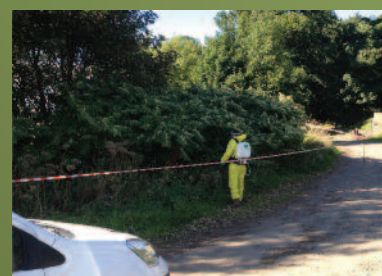
INITIAL SPRAY TREATMENT

The Solution: An appropriate herbicide which is licenced for use on and near water was selected for the treatment. A combination of application techniques was employed in order to apply the as fast a practical without threatening to the health of the trees. The large stand at the edge of the woodland was scheduled for application using a backpack sprayer, and the JK in the woodland was scheduled for application with a weed-wiper.

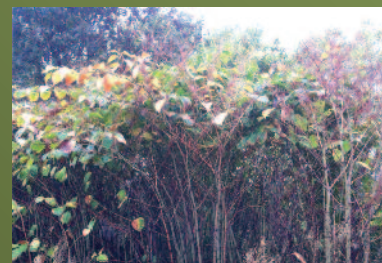
MAIN STAND ONE MONTH AFTER TREATMENT

Results: Die back of the treated stands of JK was noted in the weeks subsequent to herbicide application. The client was happy that they were able to remove fencing and allow vehicle access to the entire car park again. Subsequent site visits have noted a significant reduction in the size of stands on site and an impact to the vigour of re-growth with a greatly reduced number of stems many as 'bonsai' plants occurring in place of the previously healthy vegetative spread.

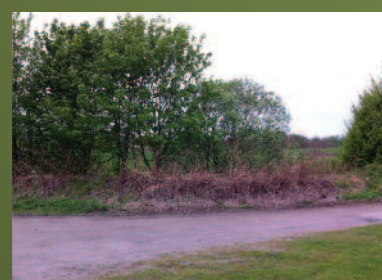
MAIN STAND OF JK TAKEN LATE MAY 2014 WITH MINIMAL RE-GROWTH VISIBLE
