Bioremediation of Hydrocarbon Contaminated Soils

The Client: Nynas UK AB, Bitumen Refinery, Dundee

Case Study – Bioremediation of Hydrocarbon Contaminated Soils

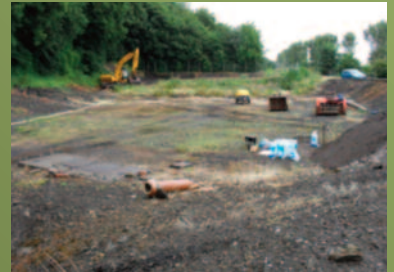
REMEDIATION AREA AT THE START OF WORKS

Soils were excavated out of the treatment bed. The treatment bed and associated infrastructure was subsequently decommissioned. Contaminated soils were screened to remove 'oversize' materials which didn't require treatment. Remaining soils were then formed into windrows on impermeable bases with breathable 'fleece' covers. Soil conditions were enhanced by adding hydrocarbon degrading bacteria, adding a balance of nutrients, and aerating the soils.

Soils were excavated out of the existing treatment bed and screened on to impermeable membranes. The treatment bed infrastructure was removed from the ground, including 2 sumps for effluent collections. Heavily contaminated groundwater was found around one of the old sumps. The client was informed and an agreement to install a temporary sump was made. The sump was pumped out regularly for the duration of the site works and monitored for 2 years.

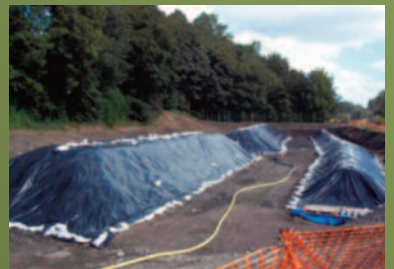
REMEDIATION WINDROWS

Impermeable windrow bases were constructed on the treatment area. Approximately 1,500m³ of impacted material was formed in to windrows on top of the impermeable bases. A microbial mixture, cultured specifically for these contaminated soils, and a soil specific balance of nutrients was added and mixed into the soils. Soils were then mixed using an Allu bucket fitted to an excavator.

Soils were covered with breathable remediation 'fleeces' which allowed a level of moisture and temperature control within the soils.

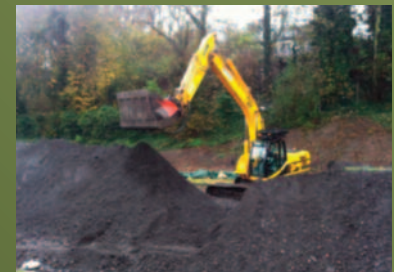
'TURNING' OF WINDROWS USING AN ALLU BUCKET

Throughout the treatment period gas and temperature levels were monitored, soils were routinely sampled and nutrient and moisture levels amended accordingly. The windrows were periodically 'turned' to aerate and evenly distribute nutrients and bacteria throughout the windrow.

Additionally, representative samples were analysed for nutrient and contaminant concentrations. The windrows were 'turned' on a regular basis to aerate the soils and when necessary, nutrients and water were added to ensure that conditions were optimal for microbial growth.

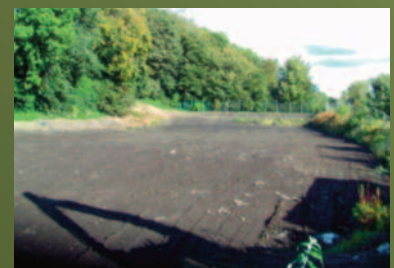
SOILS RE-USED ON REMEDIATION AREA

Project Conclusion: The client's consultant carried out a risk assessment using chemical analysis from the windrow soils. Soils at the conclusion of the project were assessed to be suitable for re-use in the treatment area.

The site was subsequently demobilised with the treated soils spread over the treatment area.

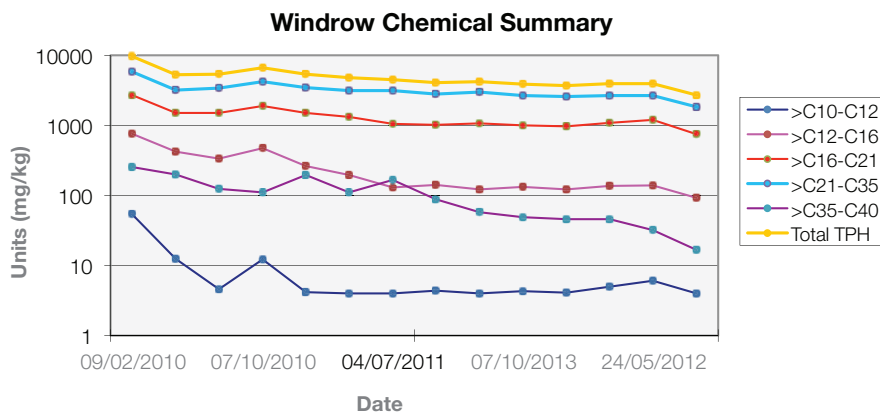
Analytical Data : The table below shows analytical results recorded through the treatment works. Concentrations of Total Petroleum Hydrocarbons (TPH) were significantly reduced by the bioremediation works. A 72% decrease in TPH was measured over the course of the project. The lightest and heaviest fractions C10-C12 and C35-C40 showed the most significant reductions with a 93% decrease in concentrations in both fractions.
