## Former gasworks below an existing house – Scotland

**The Client:** Local Authority (Central Belt - Scotland)

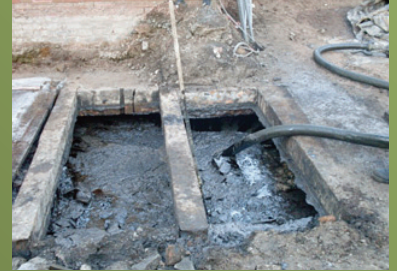
**The Challenge:** The initial scope was to remove hydrocarbon contaminated soils from behind a residential property and install a vapour extraction system. Excavation works uncovered an old tar tank and gas holder containing oil and tar. One corner of the house had been built directly on top of the tank and straddled the gap between the tar tank and the gas holder wall.

EXPOSED TANKS FILLED WITH OIL & TAR

- Liquid from the tar tank was pumped out and sent for disposal
- Solids in the tank were excavated and sent for treatment and disposal
- The tar tank was pressure washed and backfilled with concrete
- Material between the tar tank and gas holder was excavated, for disposal, included excavating underneath the house (with appropriate support works in place).
- Air monitoring and forced air system installation
- The gas holder was back filled with concrete
- The rear garden was reinstated

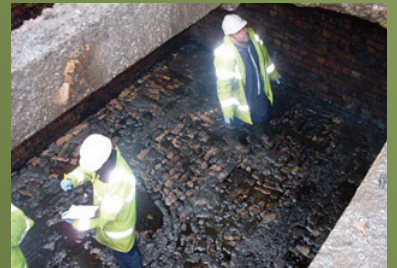
TANKS FOLLOWING OIL & TAR REMOVAL

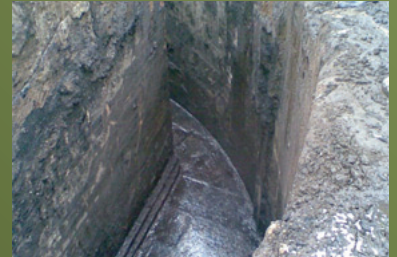
GAP BETWEEN TANK AND GAS HOLDER

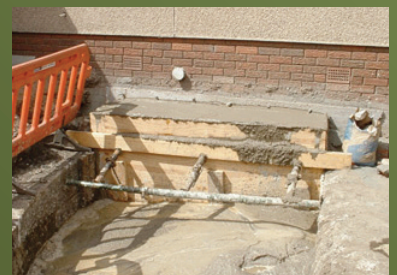
CONCRETE BACKFILL
