Red Diesel spill at a farm impacting local watercourse- East Lothian

The Client: Loss Adjuster

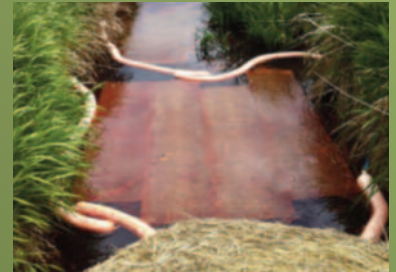
RED DIESEL SOAKED ABSORBENTS

The Solution: Emergency mitigation measures were deployed to prevent migration of the red diesel further off-site. Absorbent booms were deployed at strategic locations to stop contamination from moving downstream. A containment pond was then excavated to collect contaminated waters in order to reduce the flow entering the irrigation channel.

Following the emergency response works, local farmers were advised not to use the irrigation channel. Mitigation measures were monitored daily at first, with regular replacement of saturated absorbents.

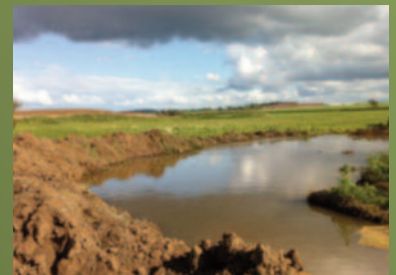
CONTAINMENT POND

- surfactant scrub of spill location and drainage runs;
- on-site treatment of approx. 100,000 litres of impacted waters from the containment pond ;
- excavation of contaminated soils for on-site treatment; and;
- bioremediation of contaminated soils.

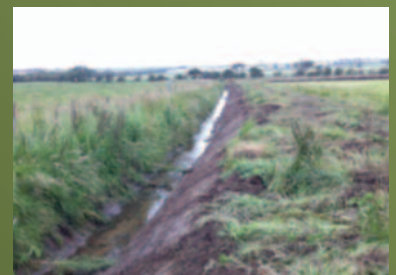
DRAINAGE TRENCH FOLLOWING EXCAVATION WORKS

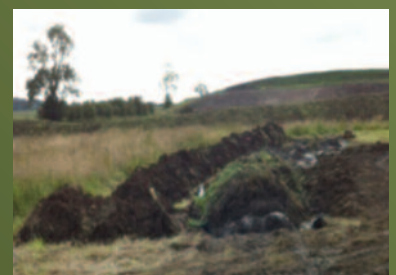
FORMATION OF BIO-PILE FOR BIOREMEDIATION
