Violet Bank, Peebles

Installation of a capping layer with anti-dig membrane in residential gardens

The Client: Scottish Borders Council

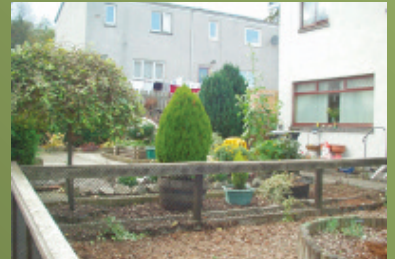
GARDENS BEFORE WORKS STARTED

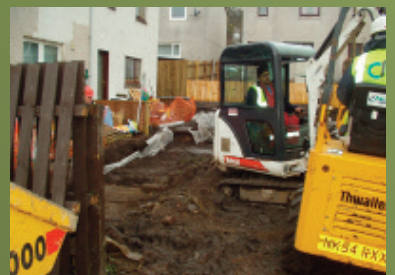
REMOVAL OF CONTAMINATED MATERIAL FROM GARDENS

Having cleared the gardens and removed all fencing the contaminated soils were excavated using mini diggers and loaded into small one tonne dumpers before being deposited into skips for removal from site.

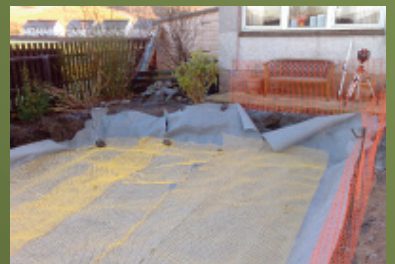
INSTALLATION OF TEXTILE AND 'GEO-GRID' PROTECTION PRIOR TO BACKFILLING.

A geo-membrane to prevent the migration of particulates was then installed along with an anti-dig barrier to protect the membrane from adventurous gardeners. Clean inert sub and top soils were then imported to form the capping layer.

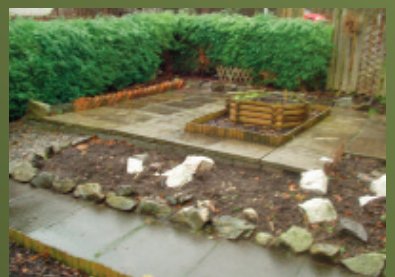
GARDENS AFTER REMEDIATION PRIOR TO PLANT RE-INSTALLMENT

Following this the gardens were reinstated as agreed with the home owners, including paths, sheds, ponds, plants, etc.
